# Manhole Inspection Summary

Manhole # S33UU\_016MH

**Location** Address: **5 29TH ST**

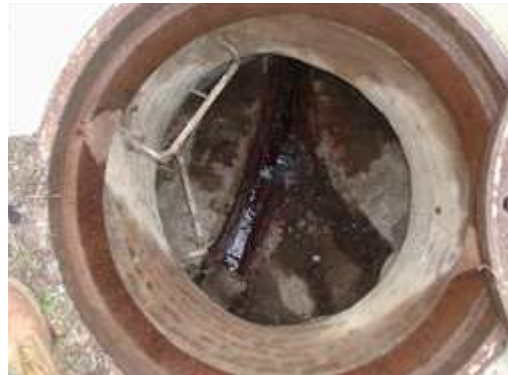
Top View

Evidence of surcharge - Bench debris.  
Channel debris.

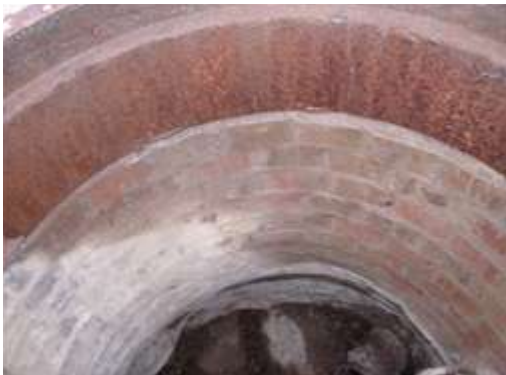
Defect

Frame leaks. Adjustment and Barrel  
infiltration - other side.

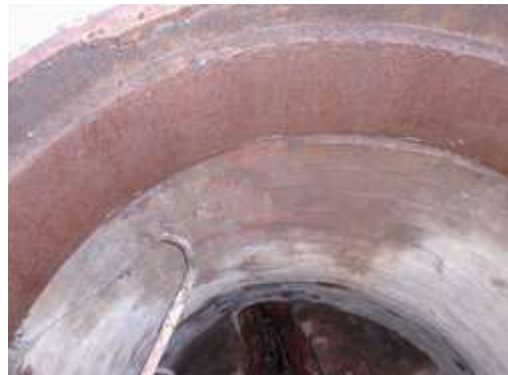
Defect

Frame leaks. Adjustment and Barrel  
infiltration.

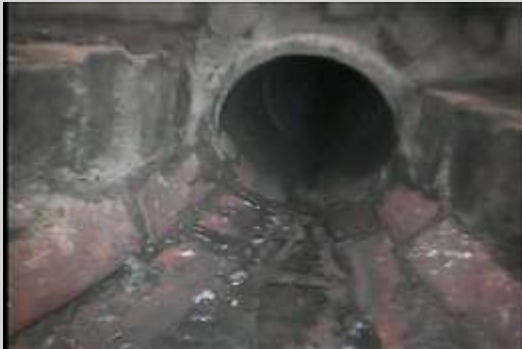
### 8 in. Circular Gravity Sewer Pipe Out @ 12 O'Clock

Invert Depth: **6.50** (ft.) Flow Characteristics: **Slow**

Infiltration: **None** Pipe Seal Cond: **Unknown**

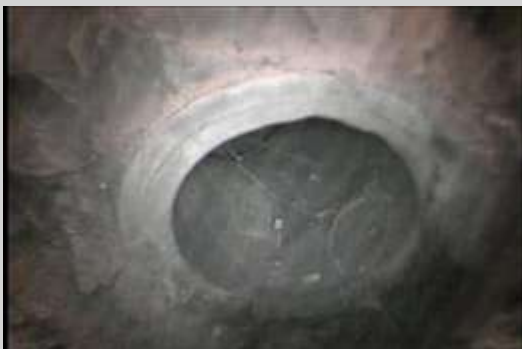
### 8 in. Circular Gravity Sewer Pipe In @ 5 O'Clock

Invert Depth: **5.75** (ft.) Flow Characteristics: **Slow**

Infiltration: **None** Pipe Seal Cond: **Unknown**

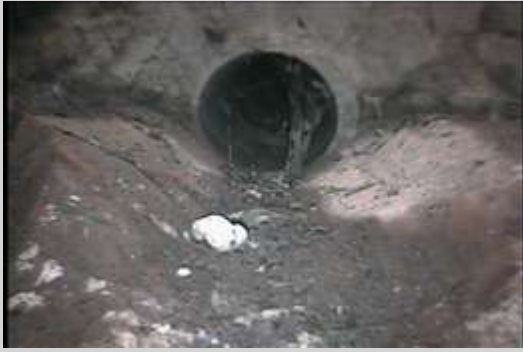
Pipe In @ 6 O'Clock

Deposits: ☐ None ☒ **Mud** ☐ Sludge ☒ **Debris** ☐ Grease

Silt Depth: **0.5** (in.) Deposits Extent: **Light**

Infiltration: **Evidence**

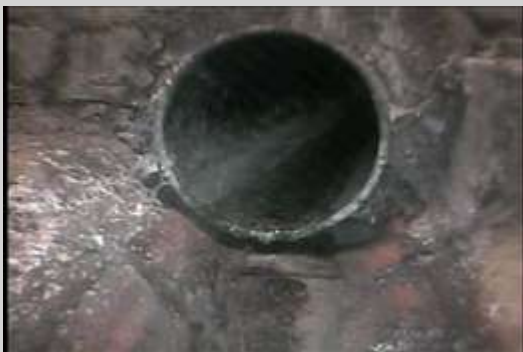
Pipe In @ 7 O'Clock

Deposits: ☒ **None** ☐ Mud ☐ Sludge ☐ Debris ☐ Grease

Infiltration: **None**
